CAFO FACILITY INSPECTION REPORT

<u>8365218001</u> WDID NUMBER	<u>Bert and Patricia Van Dam</u> OWNER NAME	<u>Two B Dairy</u> FACILITY NAME
<u>CAG018001</u> NPDES NUMBER	<u>Ex. 6 Personal Privacy (PP)</u> OWNER ADDRESS	
<u>R8-2007-0001</u> RWQCB ORDER NO.	<u>Ontario, CA 91762</u> OWNER CITY AND STATE	<u>Ontario, CA 91762</u> FACILITY CITY AND STATE
<u>04/08/2013</u> SCHEDULED INSPECTION DATE	<u>Patricia Van Dam</u> OWNER CONTACT	<u>Patricia Van Dam</u> FACILITY CONTACT
<u>04/08/2013</u> ACTUAL INSPECTION DATE	<u>Ex. 6 Personal Privacy (PP)</u> OWNER PHONE NO.	
<u>Santa Ana River</u> RECEIVING WATER	<u>Ex. 6 Personal Privacy (PP)</u> FACILITY LATITUDE	<u>Ex. 6 Personal Privacy (PP)</u> FACILITY LONGITUDE

REPORT PREPARED BY: Anthony D'Angelo (PG Environmental, LLC) ON 04/18/2013

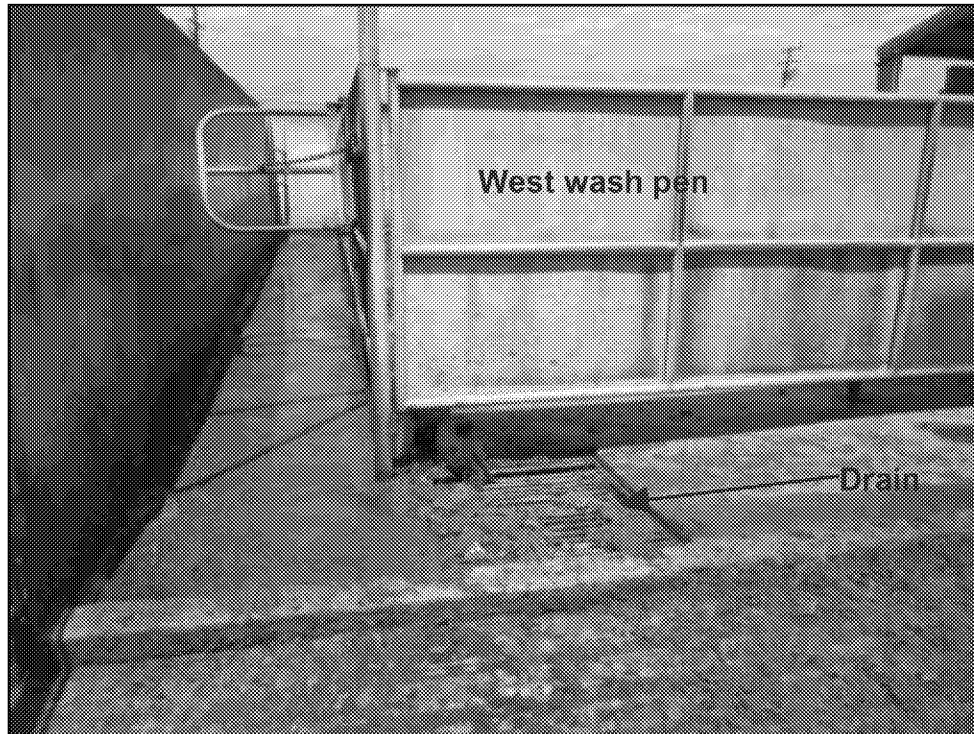
Photograph 2. View facing north of the western wash pen drain. Note this drain collects process wastewater from the wash pen and conveys it southwest to four (4) check valves along the north side of field No. 1. Note the eastern wash pen is no longer used at the Facility.

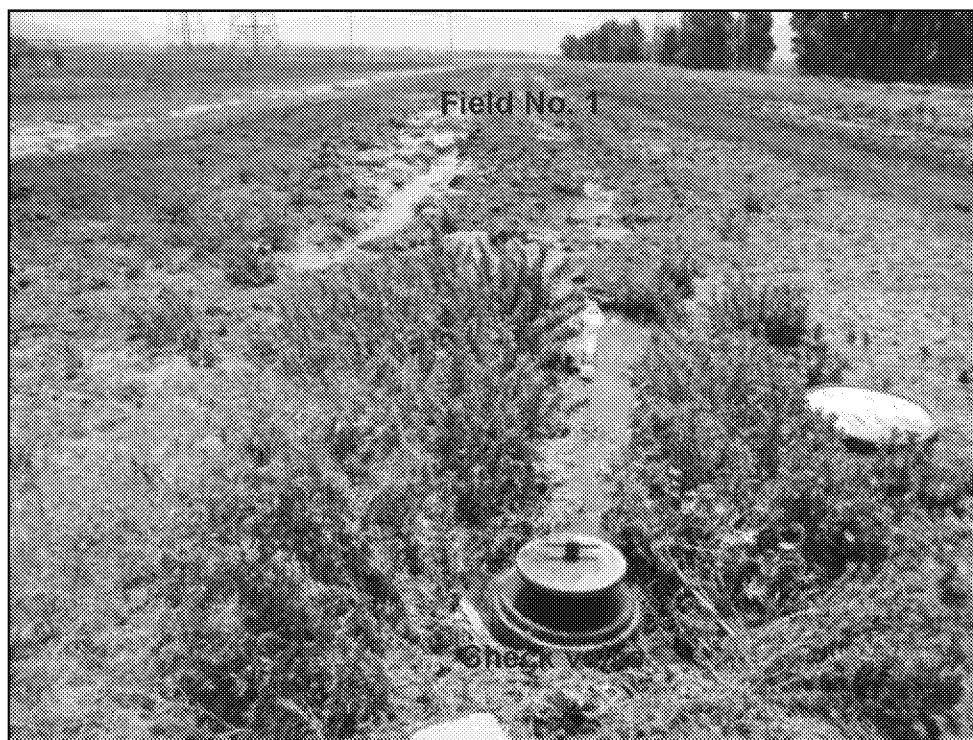
Photograph 3. View facing south of a check valve actively releasing process wastewater into field No. 1 on the west side of the Facility.

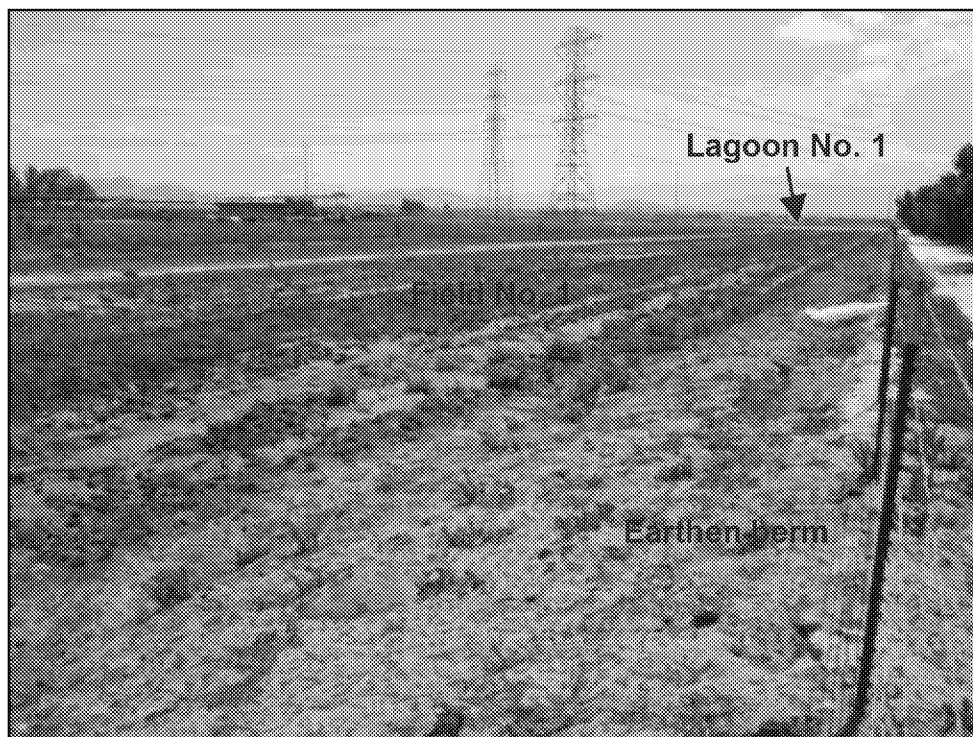
Photograph 4. View facing southeast of field No. 1, shown in Photograph 3. Note the earthen berm along the western field perimeter appeared well maintained.

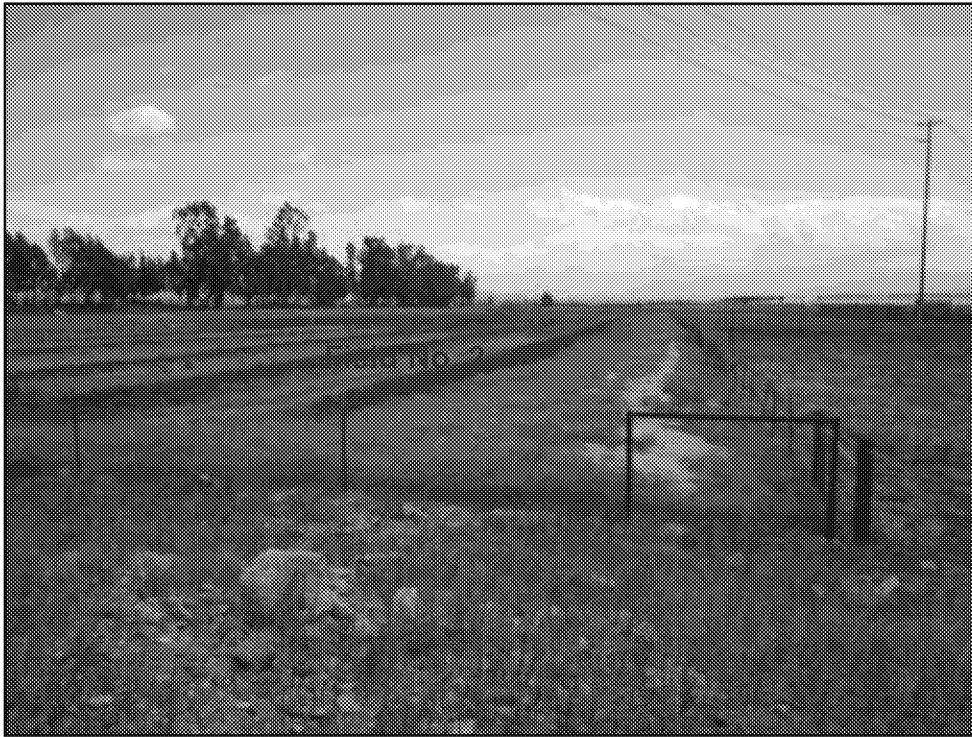
Photograph 5. View facing south of field No. 2 located on the east side of the Facility. Note process wastewater had not been land-applied onto field No. 2 in over a year according to Facility representatives.

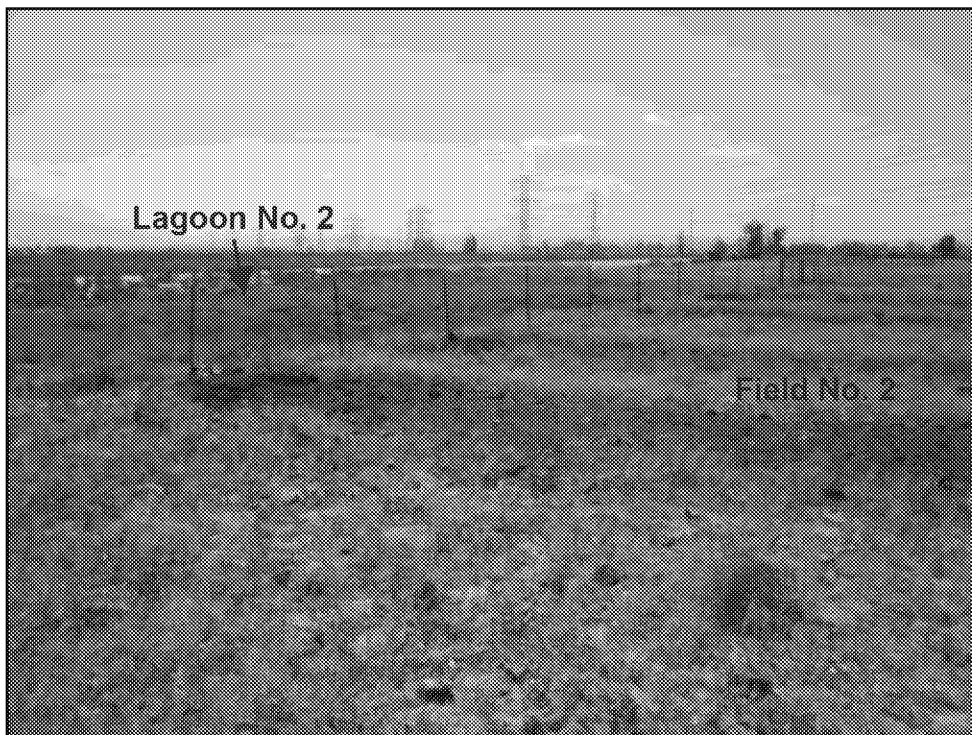
Photograph 6. View facing southwest of the south end of field No. 2. Note excess process wastewater or storm water runoff from the field flows south into lagoon No. 2 located in the southeast portion of the Facility.

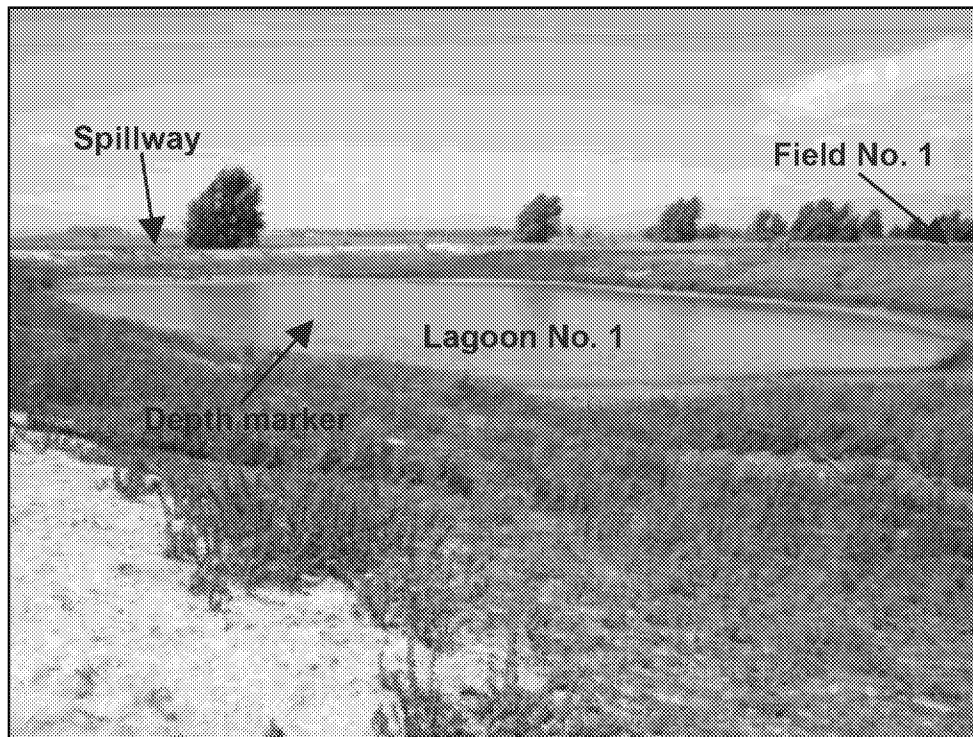
Photograph 7. View facing northwest of lagoon No. 1 in the southwestern portion of the Facility. Note the lagoon contained approximately one (1) foot of accumulated process wastewater.

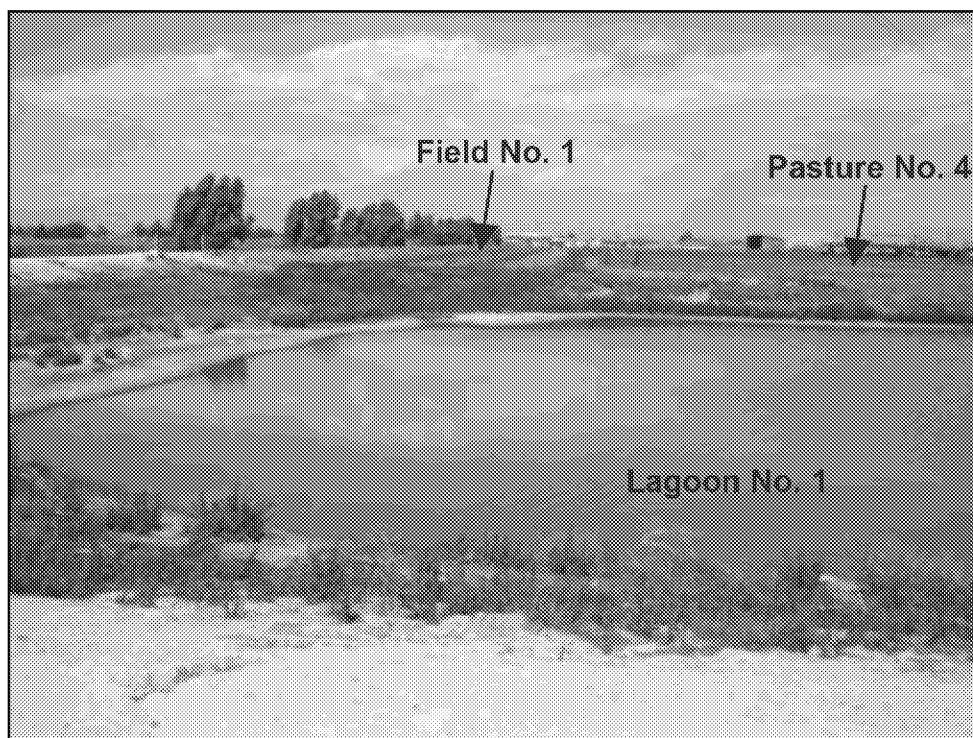
Photograph 8. View facing north of lagoon No. 1, shown in Photograph 7. Note excess process wastewater and storm water runoff from field No. 1 flows south into lagoon No. 1.

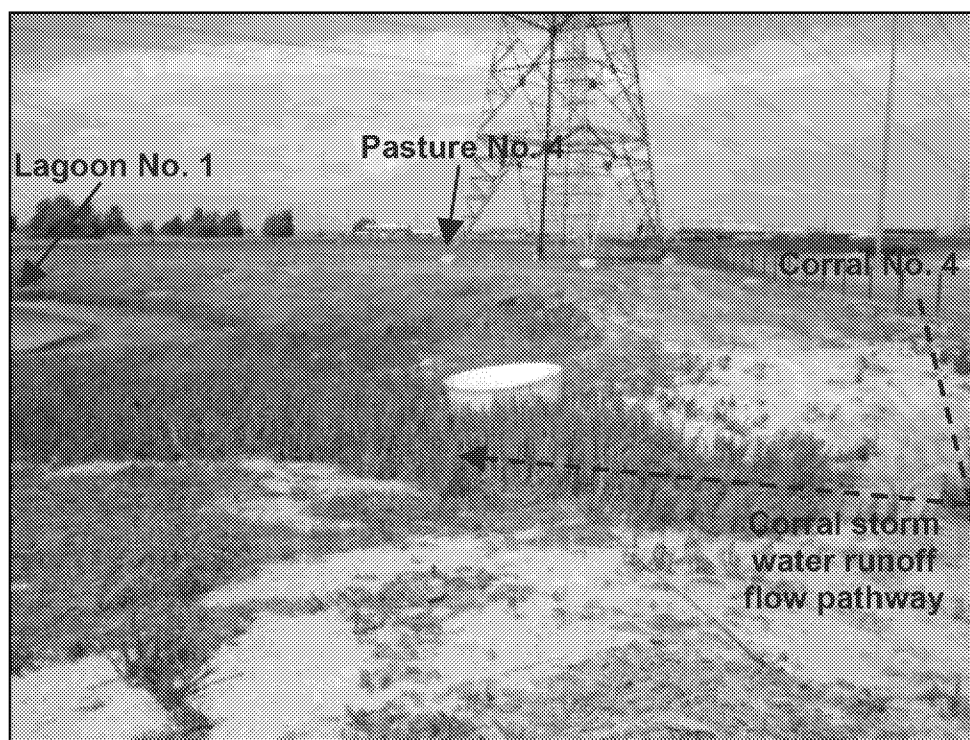
Photograph 9. View facing north of the storm water runoff flow pathway from the western corrals into the east side of lagoon No. 1.

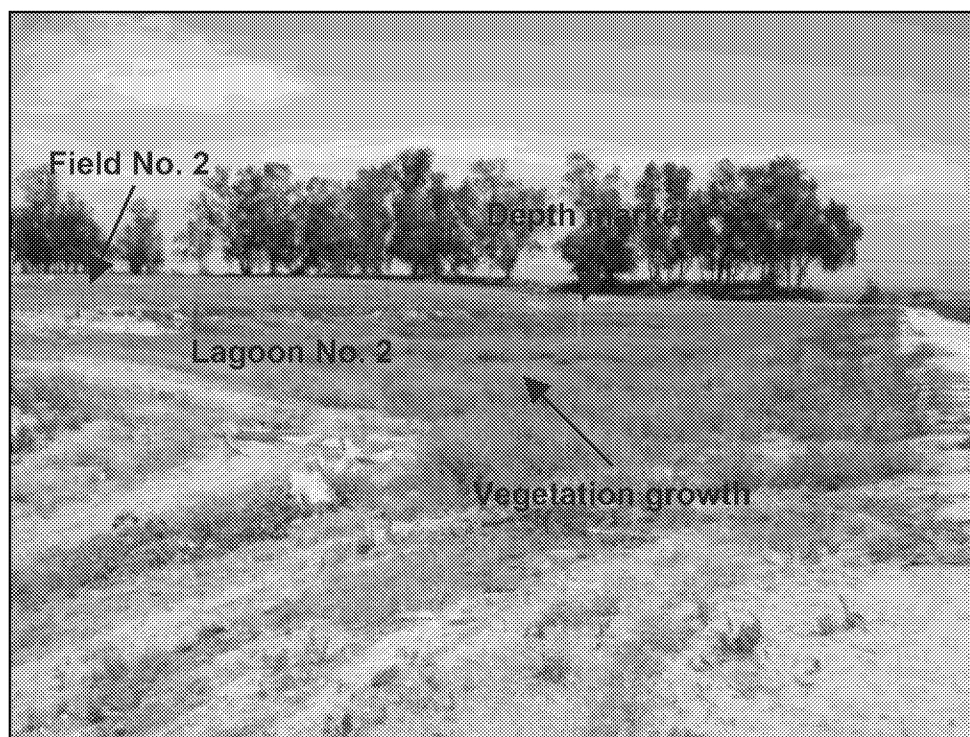
3. Accumulated manure solids and vegetation growth was observed inside lagoon No. 2 located in the southeastern portion of the Facility (refer to Photos 10, 11, and 12). The Discharger must design and maintain all containment structures per the EWMP as required by Provision VII.C.3.a of the Permit.

3. The inspector observed, during the inspection, that vegetation growth potentially affecting the containment structure capacity was present in lagoon No. 2 located in the southeast portion of the Facility (refer to Photos 10, 11, and 12). Mr. BJ Van Dam stated that weed abatement is a constant battle, and that weeds are usually mowed two (2) times per year. As a result, the overall capacity of the containment structures at the Facility may be diminished. The Discharger must design and maintain all containment structures per the EWMP as required by Provision VII.C.3.a of the Permit.

Photograph 10. View facing northeast of lagoon No. 2 located in the southeastern portion of the Facility. Note the vegetation growth.

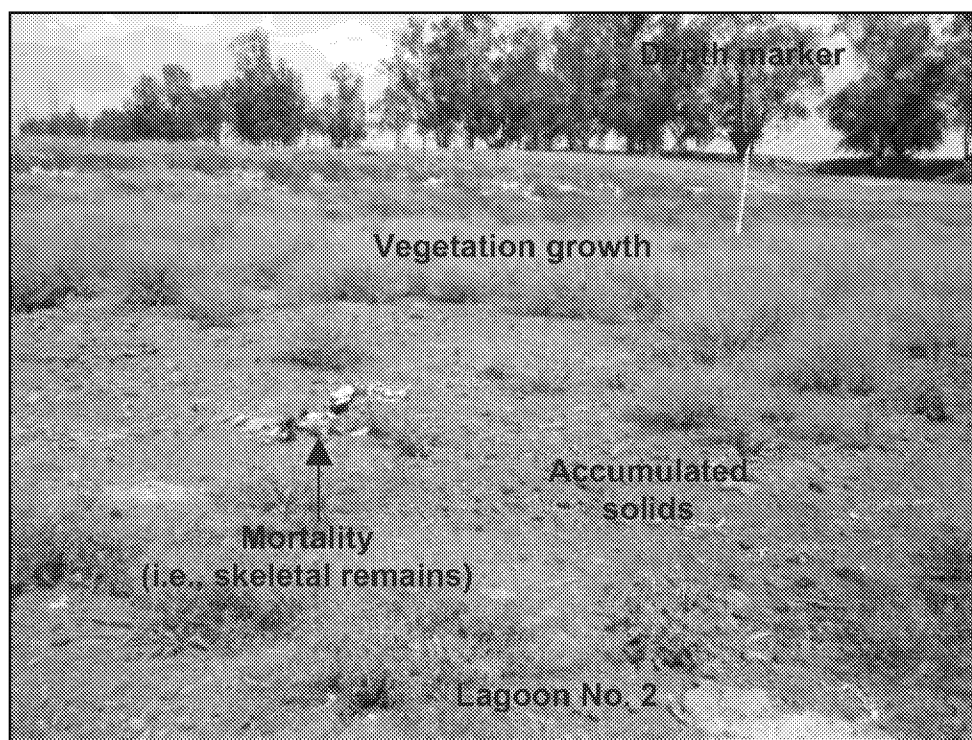
1. Evidence of previous mortalities (i.e., skeletal remains) were observed inside lagoon No. 2 located in the southeastern portion of the Facility, and in pasture No. 1 located in the northwestern portion of the Facility (refer to Photos 11, 12, and 13). Discharge Prohibition IV.F states that "the disposal of any mortality in any process wastewater system is prohibited."

1. The inspector observed, during the inspection, evidence of previous mortality disposal (skeletal remains) in lagoon No. 2 located in the southeastern portion of the Facility and in pasture No. 1 located in the northwestern portion of the Facility (refer to Photos 11, 12, and 13). Mr. BJ Van Dam stated that all mortalities at the Facility are hauled away immediately by Stiles Animal Removal, Inc.; however, coyotes have been known to kill calves and drag them around the Facility and offsite. Discharge Prohibition IV.F states that "the disposal of any mortality in any process wastewater system is prohibited."

2. The inspector observed, during the inspection, accumulated solids inside lagoon No. 2 located in the southeast portion of the Facility (refer to Photos 11 and 12). As a result, the overall capacity of the containment structures at the Facility may be diminished. The Discharger must design and maintain all containment structures per the EWMP as required by Provision VII.C.3.a of the Permit.

Photograph 11. View facing northeast of mortality, accumulated solids, and vegetation growth inside lagoon No. 2.

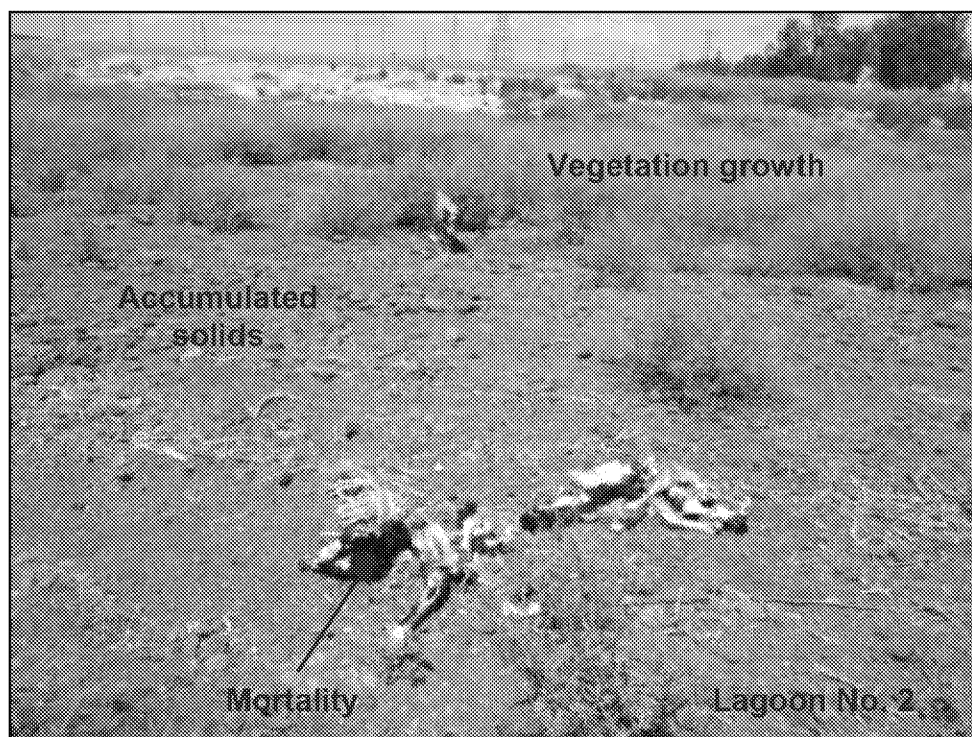
Photograph 12. Close-up view of the mortality, accumulated solids, and vegetation growth inside lagoon No. 2, shown in Photograph 11.

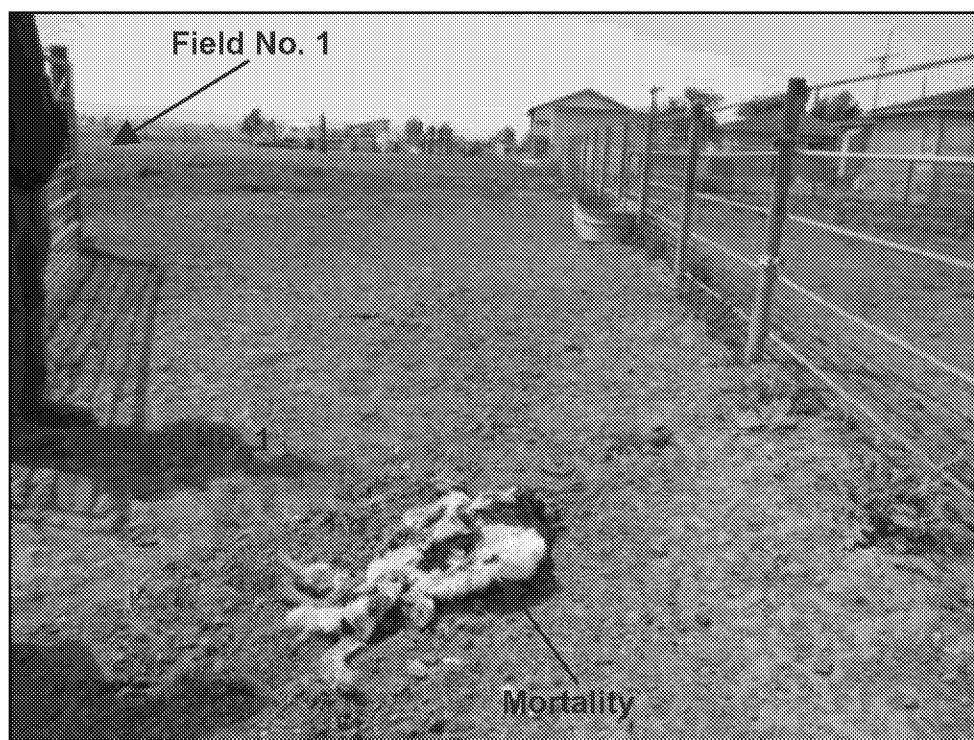
Photograph 13. View facing west of mortality located inside pasture No. 1.

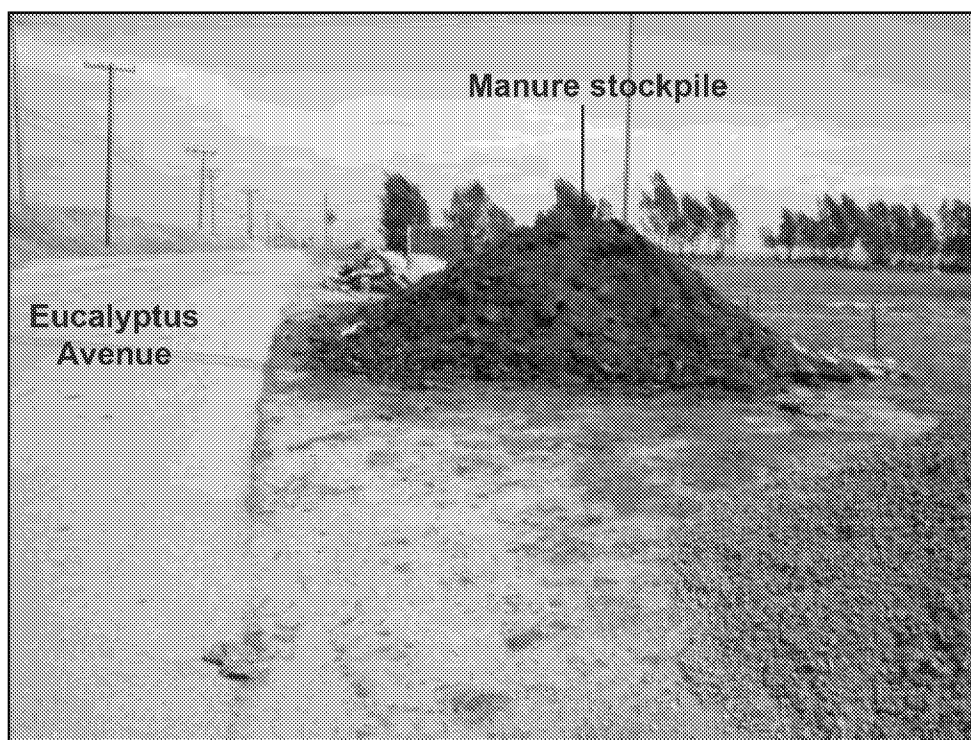
Ms. Van Dam stated that the corrals are typically cleaned four (4) times per year and were last cleaned two (2) months prior to the inspection. A public pick-up manure stockpile is maintained along Eucalyptus Avenue, north of field No. 2 (refer to Photo 15). A manure stockpile located in the eastern corrals is used to replenish this stockpile on an as-needed basis (refer to Photo 14). Mr. BJ Van Dam stated that stockpile is a combination of manure from the most recent corral cleaning event and manure leftover from corral cleaning events that occurred in 2012. A portion of the manure stockpile in the eastern corrals was approximately six (6) months old, per Mr. BJ Van Dam. Ms. Van Dam stated that manure was not removed from the Facility during the 2012 monitoring year due to budget constraints; therefore, manure tracking manifests were not generated. Manure is typically hauled offsite by Rico Trucking. Ms. Van Dam stated that all mortalities are removed from the Facility immediately by Stiles Animal Removal, Inc.

Photograph 15. View facing east of the public pick-up manure stockpile located on Eucalyptus Avenue, north of field No. 2.

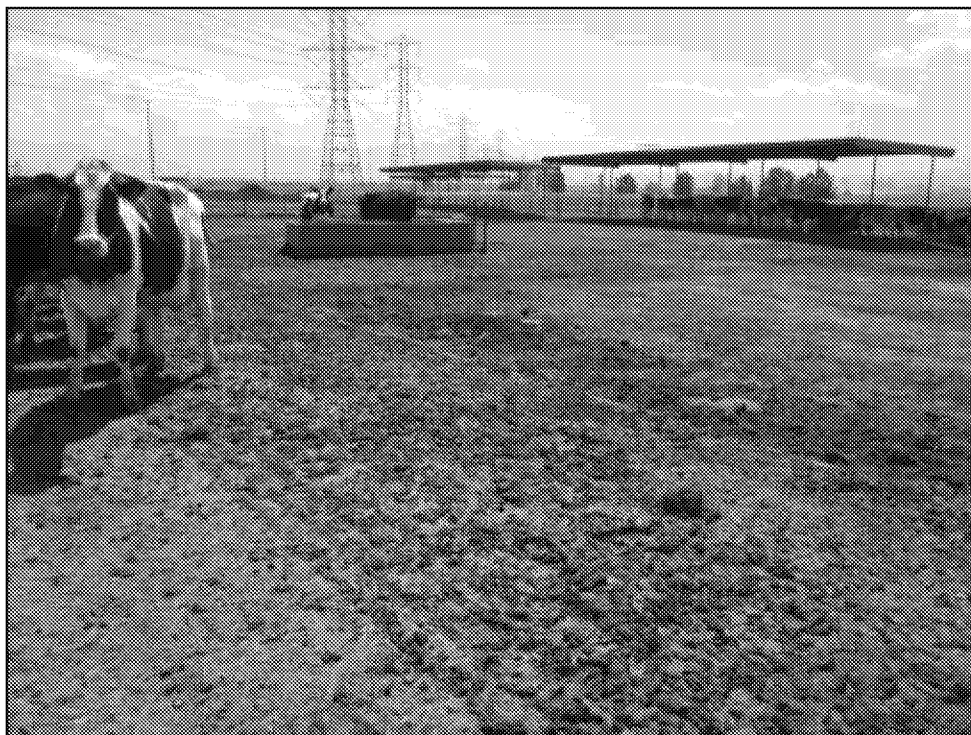
1. The inspector observed, during the inspection, adequate housekeeping and pollution prevention practices at the Facility. Corrals and feed lanes appeared to be well maintained at the time of the inspection (refer to Photo 16).

Photograph 16. View facing southwest of the western corrals. Corrals appeared to be well maintained at the time of the inspection.
